# Manhole Inspection Summary

Manhole # S55E\_\_006MH

Insp Date: **7/21/08 2:41 PM**

**Location** Address: **3800 mount pleasant ave**

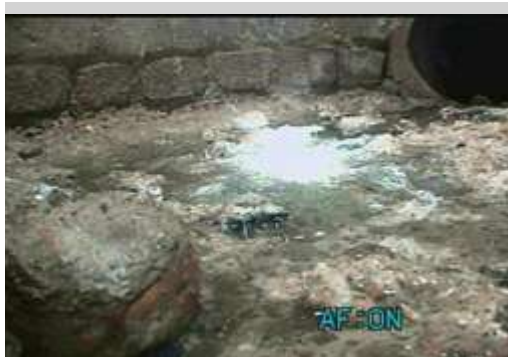
Defect 3

Condition: ☐ Sound ☐ Cracked ☐ Root Intrusion ☐ Deteriorated ☐ Leaks ☒ **Debris**

channel debris

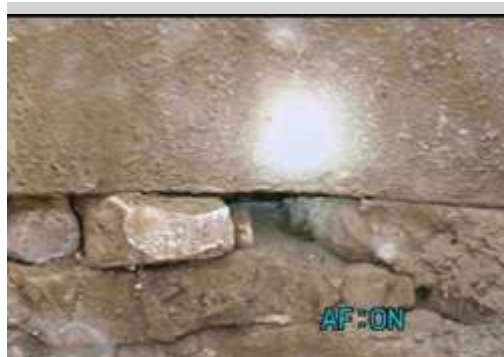
Defect 2

Condition: ☐ Sound ☐ Cracked ☐ Root Intrusion ☒ **Loose Brick** ☒ **Deteriorated**

chimney loose bricks,deteriorated, frame adj

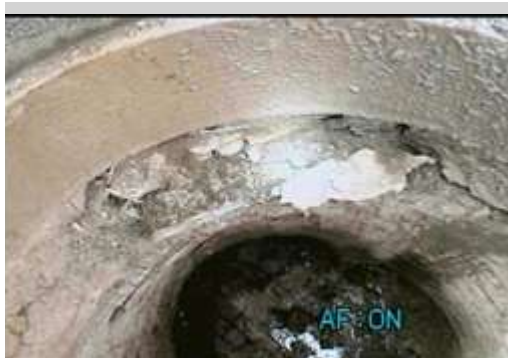
Defect 1

Offset: **2** (in.)

offset

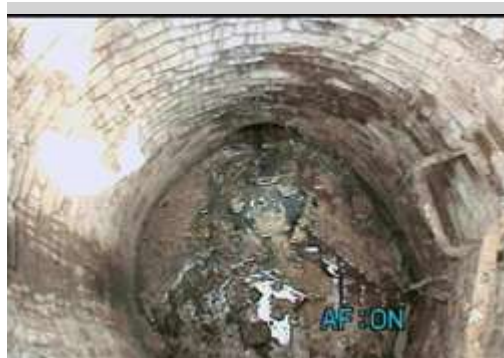
Defect

Count: **3** Missing: **1** ☒ **Corroded**

1 step missing & corroded steps

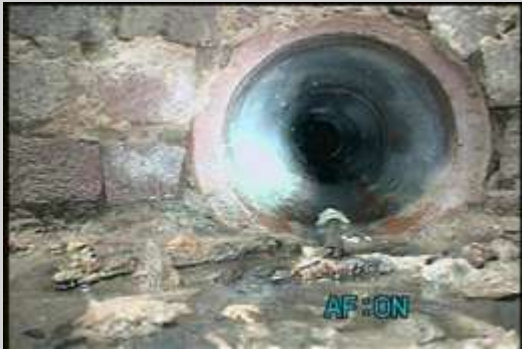
12 O'Clock Outflow

8 in. Circular Gravity Sewer  
Pipe Out @ 12 O'Clock

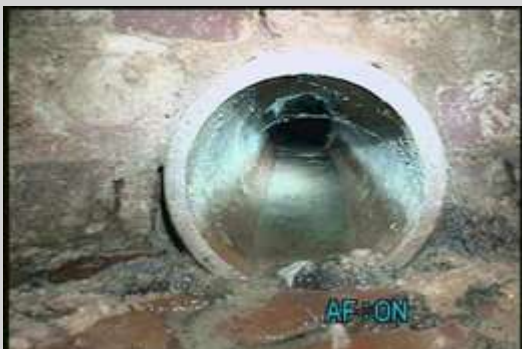
3 O'Clock Inflow

8 in. Circular Gravity Sewer  
Pipe In @ 3 O'Clock

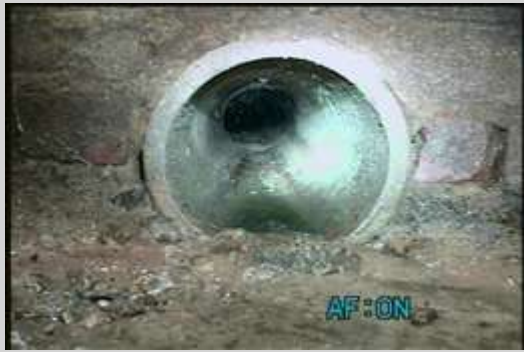
9 O'Clock Inflow

8 in. Circular Gravity Sewer  
Pipe In @ 9 O'Clock
